NATURAL ICING OF AN AXIAL-FLOW TURBOJET ENGINE  
IN FLIGHT FOR A SINGLE ICING CONDITION

By Loren W. Acker

Flight Propulsion Research Laboratory  
Cleveland, Ohio

WASHINGTON  
August 12, 1948

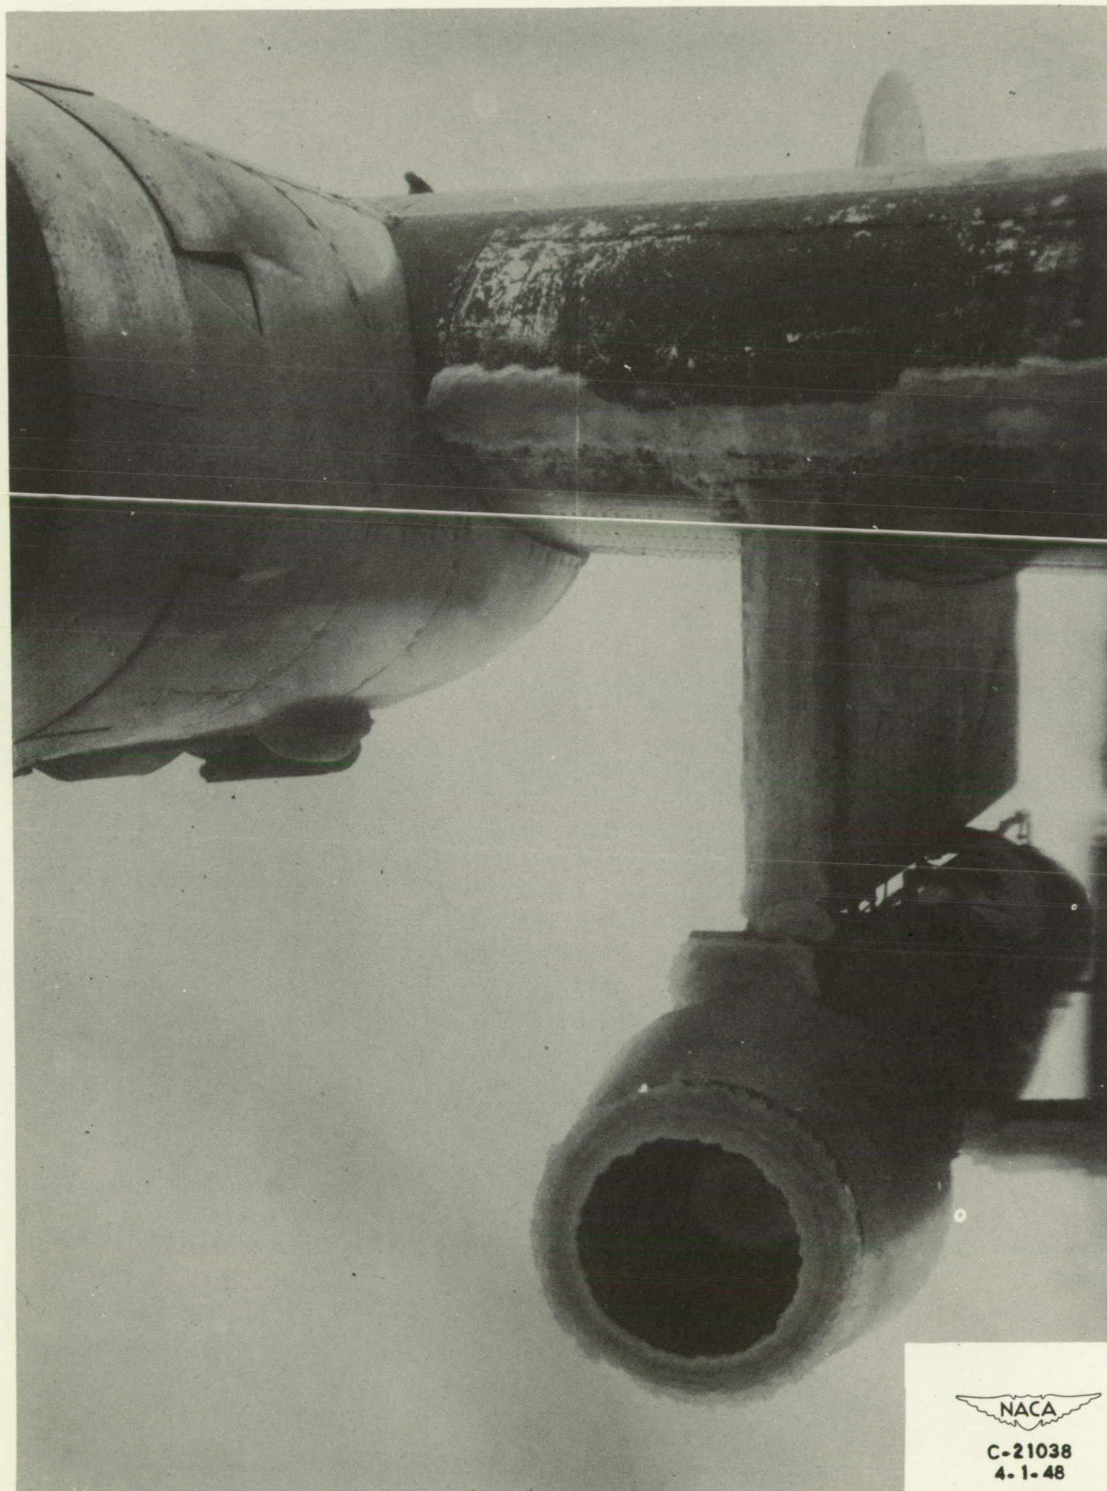
The ice formation obtained on the jet-engine cowling inlet is shown in figure 3. The degree of ice accumulation on the engine inlet is indicated by figures 4(a) and 4(b), which are side and front views, respectively, of the engine inlet photographed after landing. Very little ice, if any, collected on the engine-inlet guide vanes. The ice shown at the bottom of the inlet guide vanes is believed to consist of pieces broken from the ice formation on the starter housing or the support struts. A time history of the data taken in the icing condition is shown in figure 5. Engine jet thrust, fuel flow, and tail-pipe temperature are shown in figure 5(a); average droplet size, free-air temperature, and liquid-water content are shown in figure 5(b). Engine and icing data were taken upon entering the icing cloud and periodically during the encounter with the icing condition, which lasted for approximately 1 hour. The engine speed was maintained at 11,000 rpm. A sudden drop in engine thrust as the airplane entered the icing cloud is believed to be a result of ice collection on the cowl lip, which disrupted the air flow and destroyed the pressure recovery at the compressor inlet.

Figure 3. - Front view of ice formation on engine and cowling in flight.
